Lower Kennebecasis Tributaries
Habitat Assessment Report
2009

*Prepared by
Ben Whalen
Laura Finnamore
January 2010*

Table of Contents

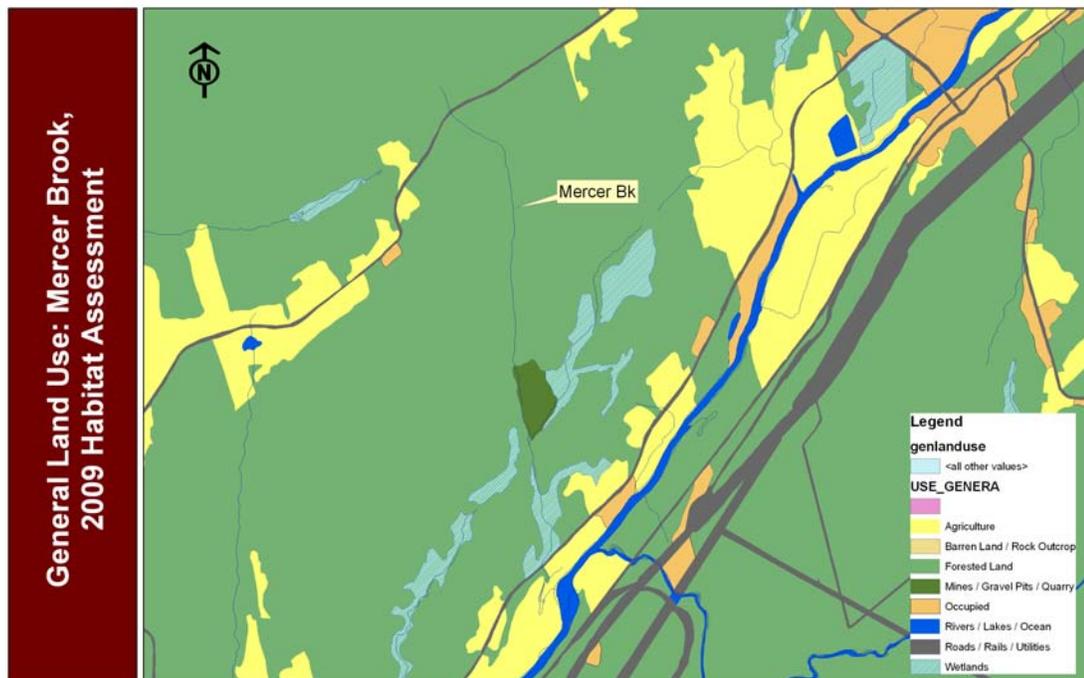
Map 6: The general land use around the Mercer Brook tributary.

events. The very bottom of this system consists of beaver ponds. Despite the logging and historical mining, Mercer Brook is likely the most intact system that was surveyed in 2009. Monitoring of the logging activity in this area is recommended.

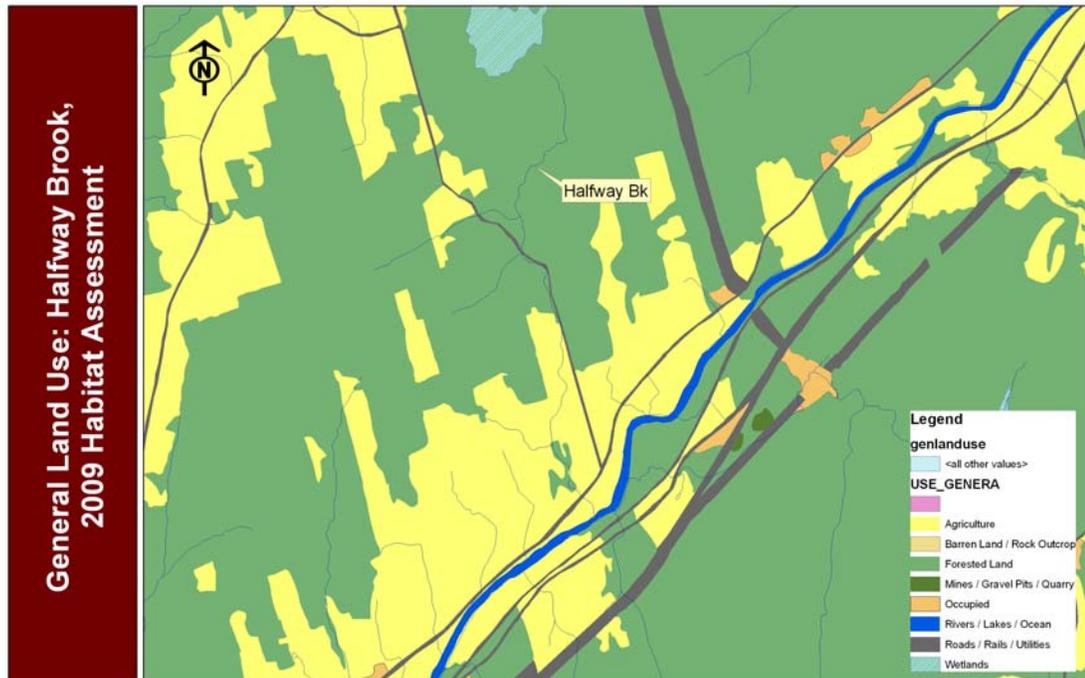
Map 7: The general land use around the Halfway Brook tributary.
